[Docket No. FAA-2012-0415; Directorate Identifier 2008-SW-065-AD; Amendment 39-17865; AD 2014-12-04]

Airworthiness Directives; Bell Helicopter Textron, Inc. (BHTI) Helicopters

ACTION: Final rule.

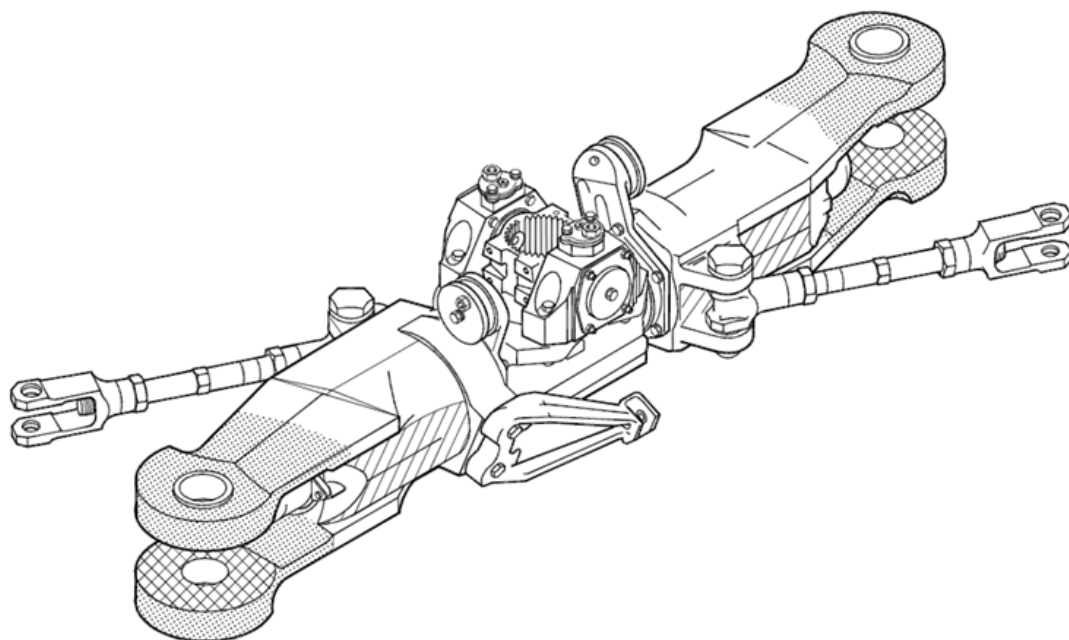
Figure 1 to Paragraphs (f)(2)(ii) and (f)(4)(ii)
Inspection of Main Rotor Hub Grip Tangs

(ii) Using a 10-power or higher magnifying glass, visually inspect the exposed surfaces of the upper and lower tangs of each grip for a crack. Pay particular attention to the lower surface of each lower grip tang from the main rotor blade bolt-bushing flange to the leading and trailing edge of each grip tang as depicted in Figure 1 to Paragraphs (f)(2)(ii) and (f)(4)(ii) of this AD.

INSPECT BUFFER PAD
FOR DELAMINATION (IF
INSTALLED)
-

AREA TO BE INSPECTED
UPPER AND LOWER TANGS
ALL EXPOSED SURFACES

(ii) Inspect each grip buffer pad on the inner surfaces of each grip tang for delamination as depicted in Figure 1 to Paragraphs (f)(2)(ii) and (f)(4)(ii) of this AD. If there is any delamination, remove the buffer pad and inspect the grip surface for corrosion or other damage.

(i) Replace any cracked grip with an airworthy grip.

(ii) Replace any grip with any corrosion or other damage with an airworthy grip, or repair the grip if the corrosion or other damage is within maximum repair damage limitations.
